**TSCA PCB INSPECTION
SPOKANE SCHOOL DISTRICT
GLOVER MIDDLE SCHOOL
SPOKANE, WASHINGTON**

FACILITY: Glover Middle School
2404 West Longfellow Avenue
Spokane, Washington 99005-1547

DATE OF INSPECTION: March 15, 2000

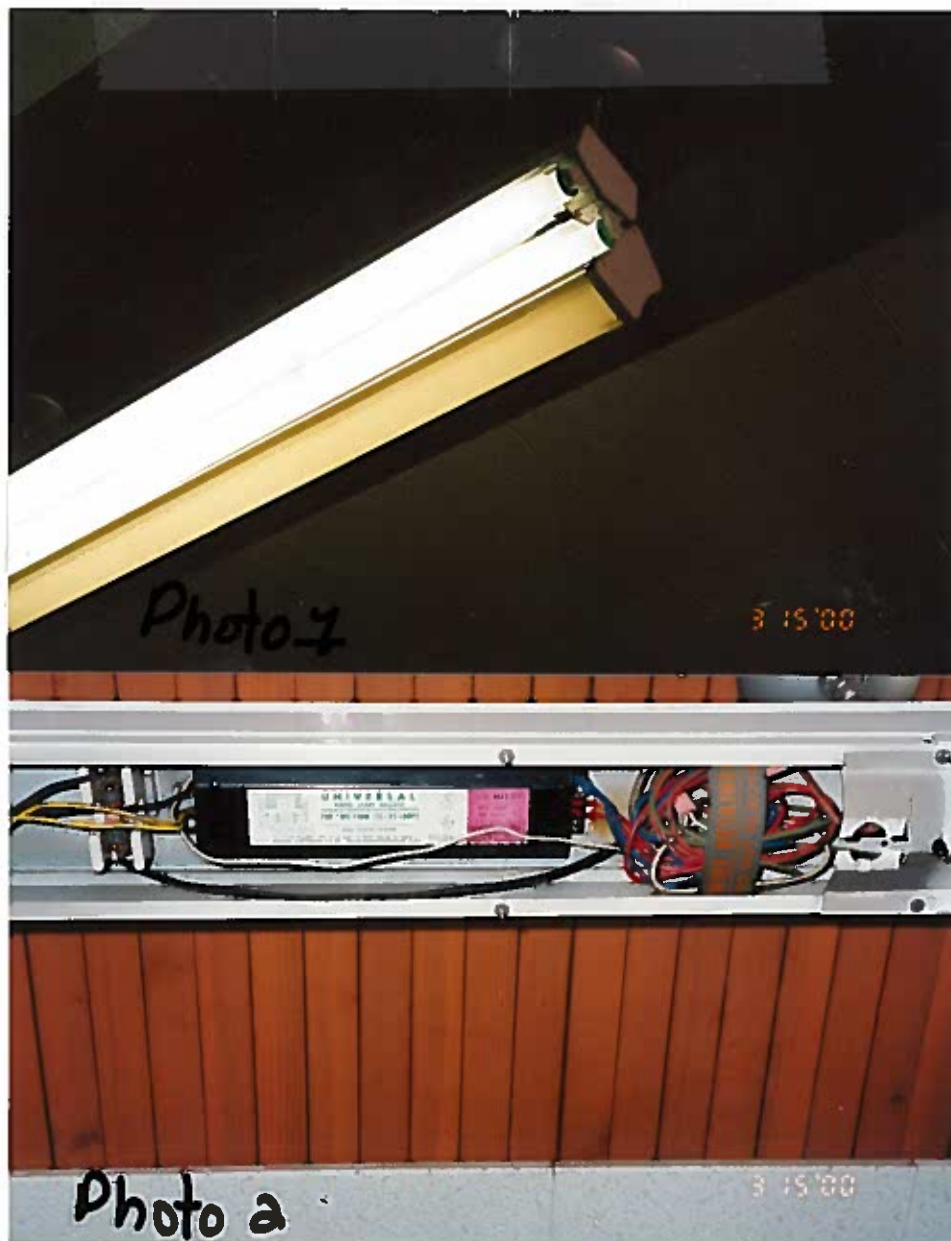
Photograph 1 taken by Eileen Hileman on March 15, 2000, at Glover Middle School, Spokane, Washington. Photograph 1 shows the interior of a light cover from the main hallway front entrance that contained a tar like substance. The exterior of the ballast cover also contained this tar like substance.

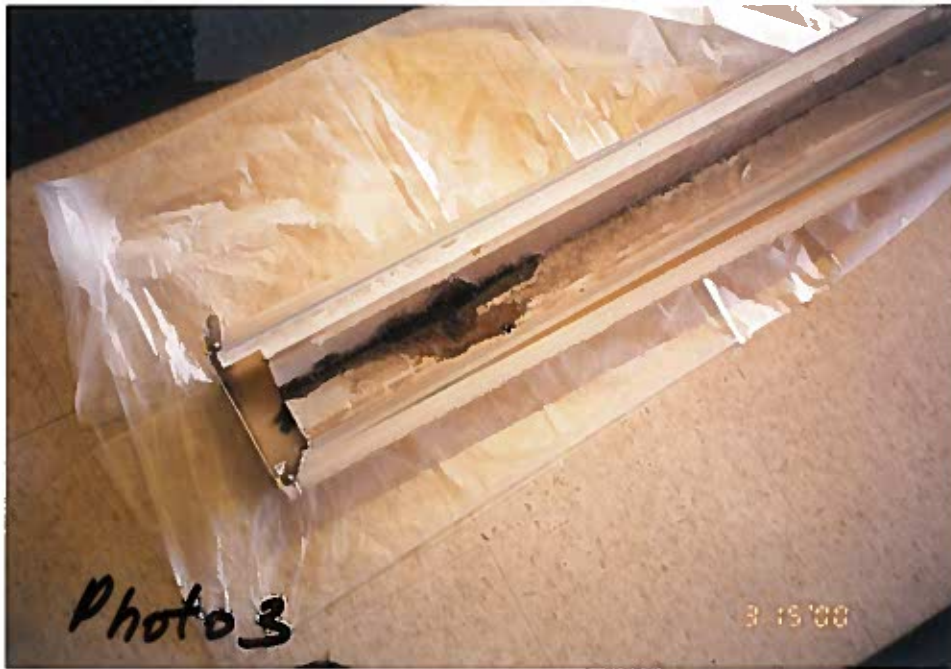
Photograph 3 was taken by Eileen Hileman on March 15, 2000, at Glover Middle School, Spokane, Washington. Photograph 3 shows the interior of the ballast cover and shows the tar like substance on the internal surfaces of the light cover.

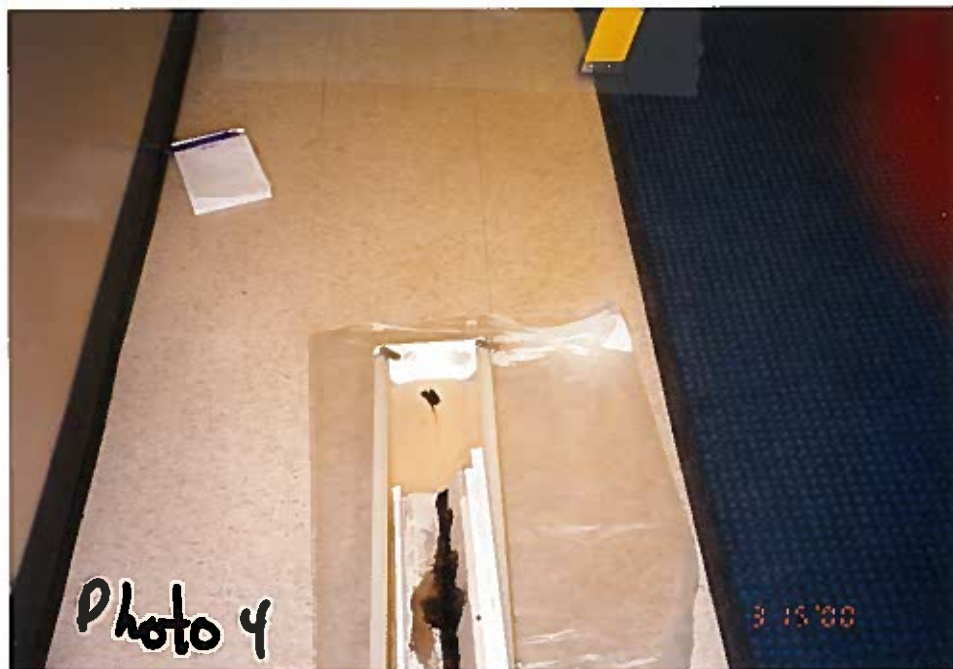
Photograph 4 taken by Eileen Hileman on March 15, 2000, at Glover Middle School, Spokane, Washington. Photograph 4 shows the tar-like substance on the interior of the light cover.

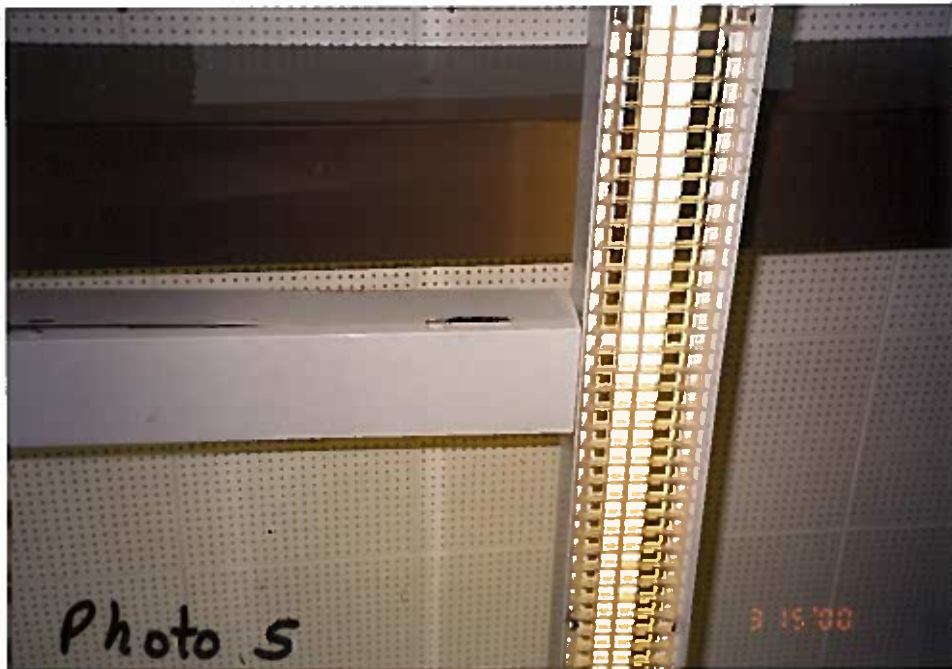
We then proceeded to Room 104. Mr. McCartney again donned protective gloves to examine a ballast. We noted a tar like substance on the external surface of the ballast (photograph 5). Upon removing the ballast cover, all present noted the tar-like substance on the exterior of the internal ballast cover (photograph 6). Photograph 7 shows the Magnetec ballast capacitor. The nameplate indicated it was a non-PCB capacitor. The capacitor was leaking at the time of the inspection.

Photograph 5 taken by Eileen Hileman on March 15, 2000, at Glover Middle School, Spokane, Washington. Photograph 5 shows a tar-like substance on the exterior of the ballast cover in Room 104.

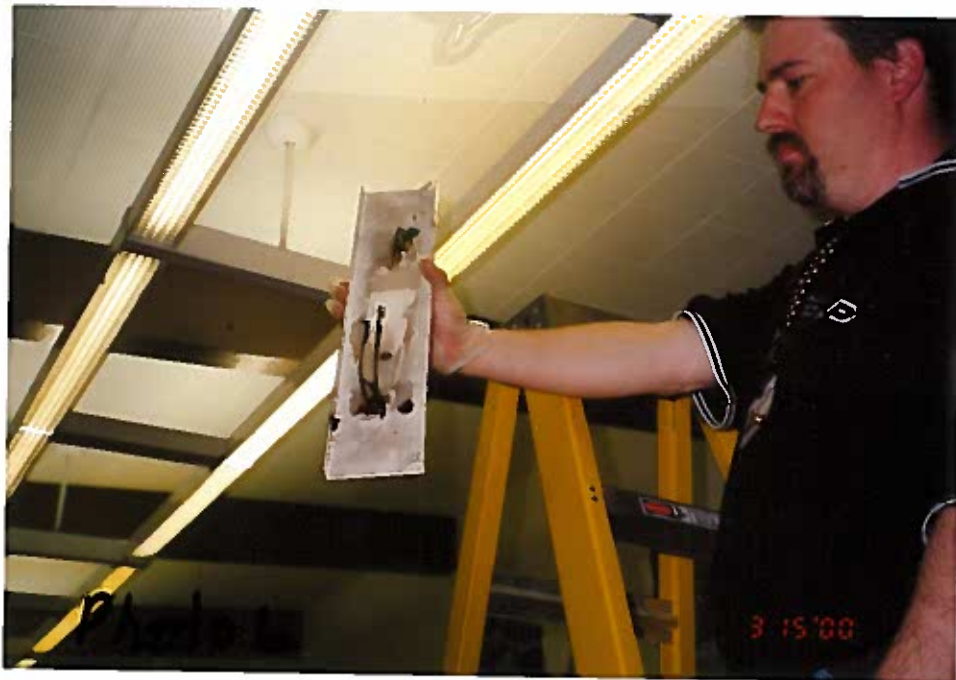
Photograph 6 taken by Eileen Hileman on March 15, 2000, at Glover Middle School, Spokane, Washington. Photograph 6 shows the leaking Magnetec ballast capacitor at the time of the inspection

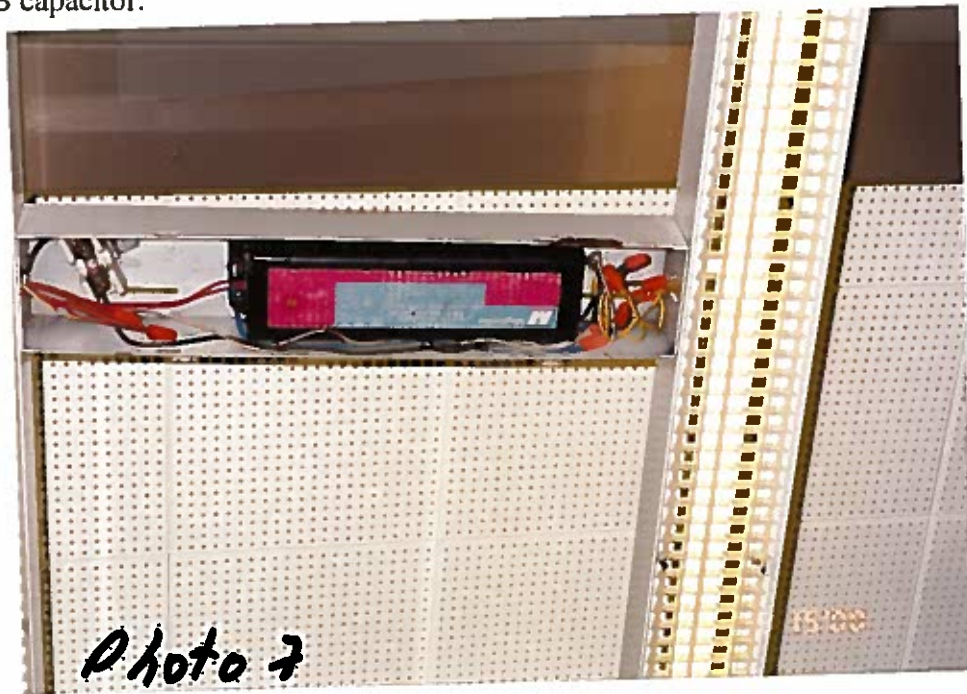
Photograph 7 taken by Eileen Hileman on March 15, 2000, at Glover Middle School, Spokane Washington. Photograph 7 shows the Magnetec ballast capacitor. The nameplate indicated it was a non-PCB capacitor.

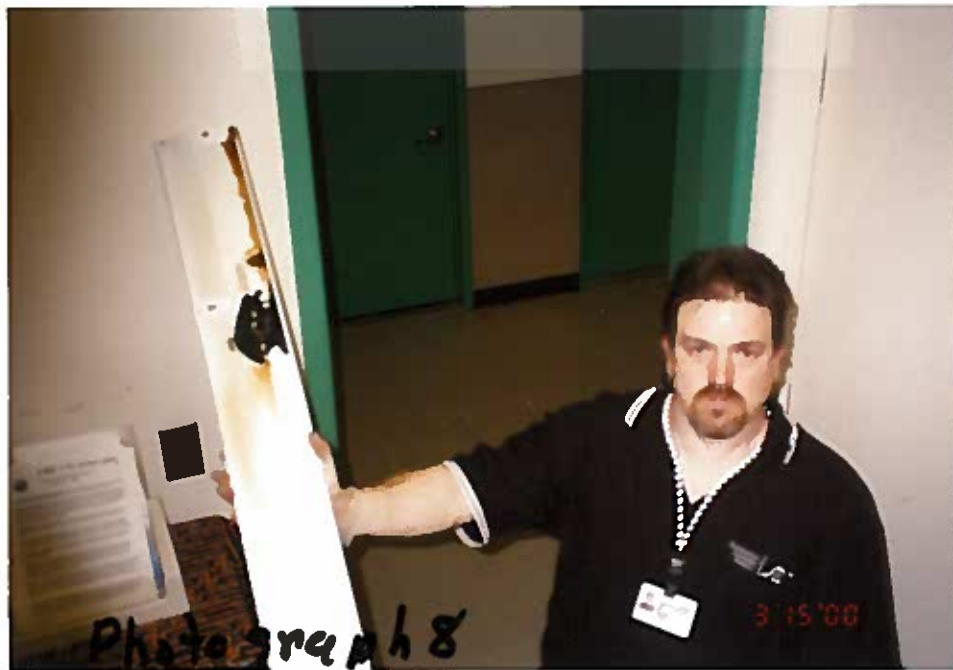
We then examined a ballast in room 108. The internal ballast cover was covered with tar-like substance (photograph 8). The ballast capacitor was a Universal Series with no indication as to PCB content on the nameplate (photograph 9). Photograph 10 shows the tar-like substance on the internal surface of the light cover itself.

Photograph 8 taken by Eileen Hileman on March 15, 2000, at Glover Middle School, Spokane, Washington. Photograph 8 shows the ballast cover of a Universal capacitor in Room 108. The internal surface of the ballast cover was contained a tar-like substance.

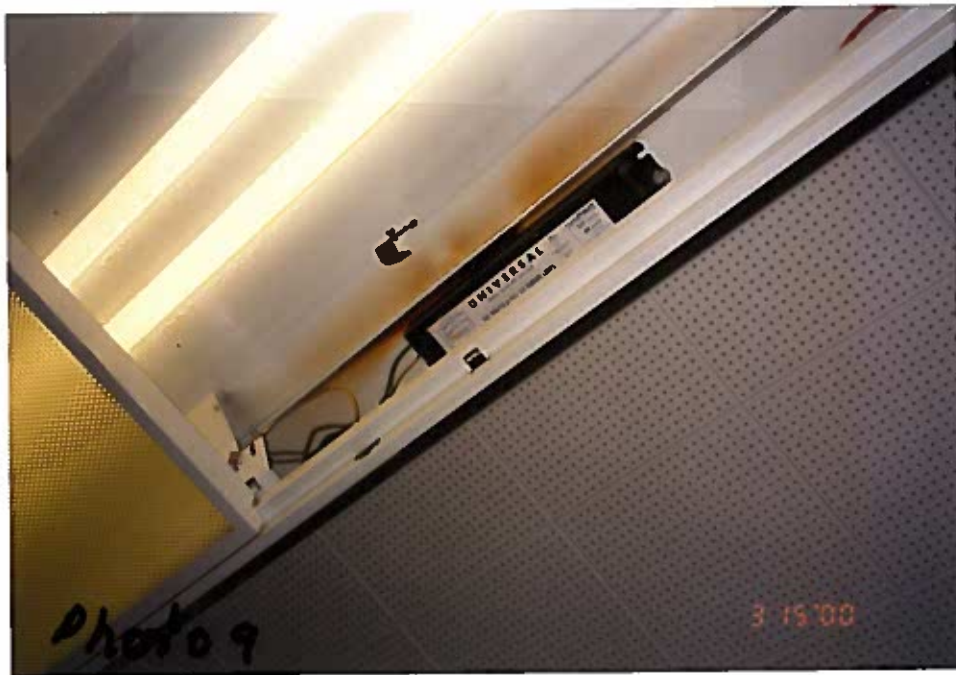
Photograph 9 taken by Eileen Hileman on March 15, 2000, at Glover Middle School, Spokane, Washington. Photograph 9 shows the leaking Universal capacitor in Room 108. There was no indication on the nameplate as to the PCB content in the capacitor and there was no manufacture date on the capacitor.

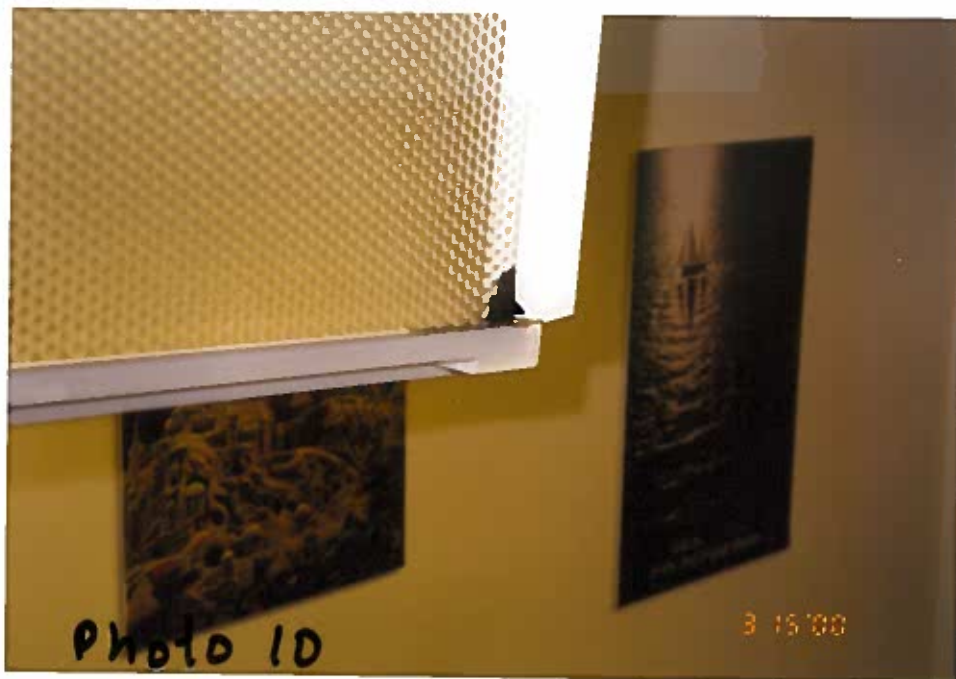
Photograph 10 taken by Eileen Hileman on March 15, 2000, at Glover Middle School, Spokane, Washington. Photograph 10 shows the tar-like substance on the internal surface of the light cover itself in Room 108.

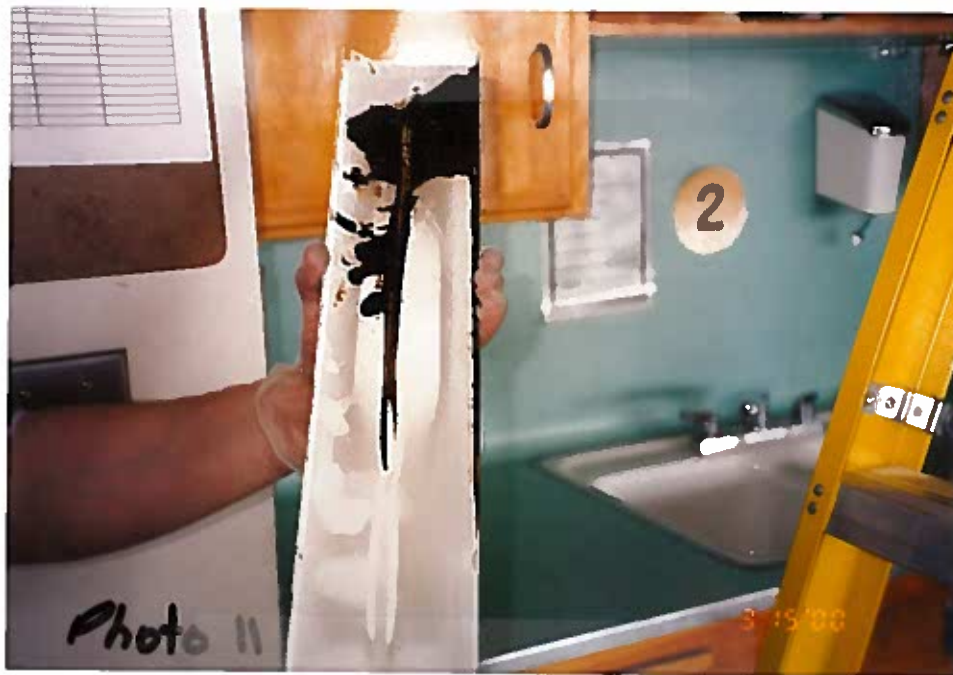
We proceeded to room 115 where we examined a Sylvania Quicktronic ballast capacitor. There was a tar-like substance on the internal surface of the ballast cover (photograph 11) and on the surface of the ballast capacitor (photograph 12). There was no indication as to the PCB content of the capacitor noted on the nameplate.

Photograph 11 taken by Eileen Hileman on March 15, 2000, at Glover Middle School, Spokane, Washington. Photograph 11 shows a tar-like substance on the internal surface of a ballast cover in Room 115.

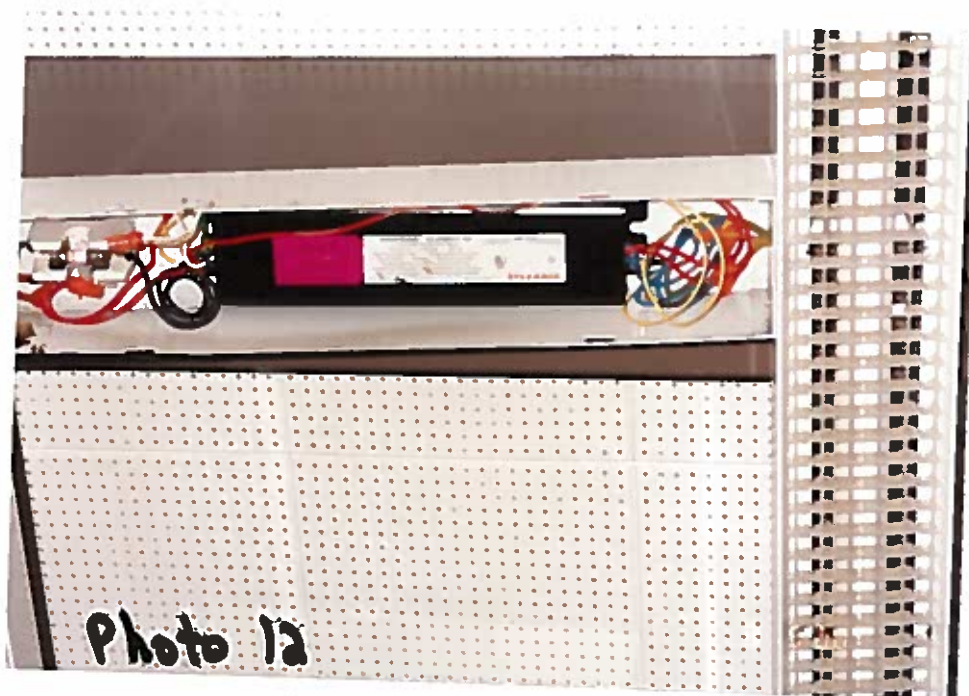
Photograph 12 taken by Eileen Hileman on March 15, 2000, at Glover Middle School, Spokane, Washington. Photograph 12 show the Sylvania Quicktronic ballast capacitor in Room 115. There was a tar-like substance on the surface of the ballast capacitor. There was no indication as to the PCB content of the capacitor noted on the nameplate nor was a manufacture date listed.

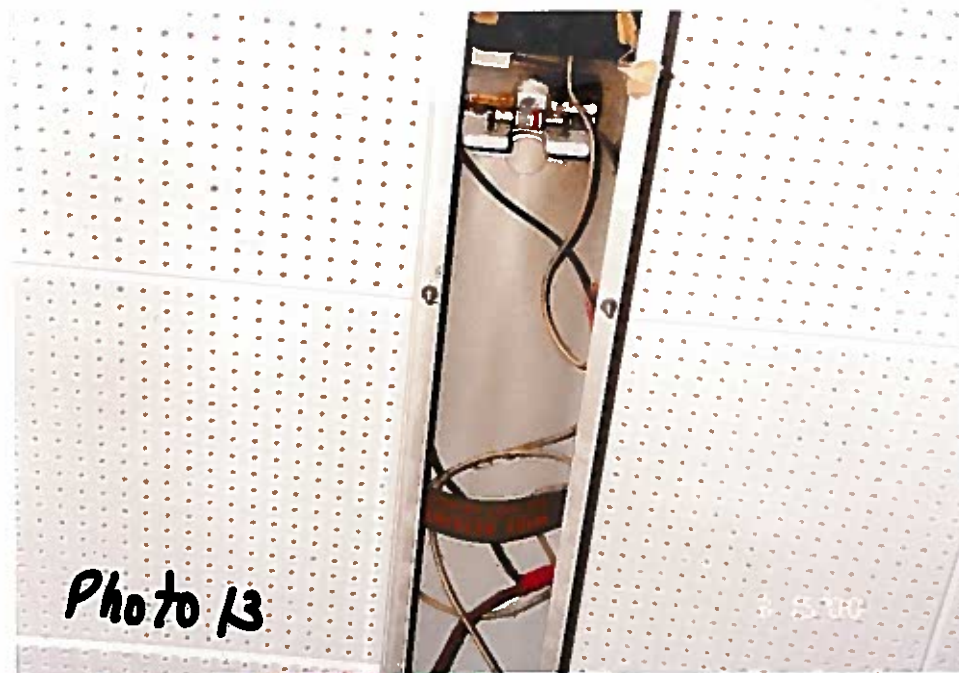
We then examined a light fixture in the main hallway, next to Room 127. Photograph 13 shows a tar like substance on the internal surface of the light fixture. Photograph 14 shows the Universal ballast capacitor with a tar like substance to the right side of the capacitor. There is no indication on the nameplate as to the PCB content in the capacitor. Photograph 15 shows the internal surface of the ballast cover with drops of tar-like substance.

Photograph 13 taken by Eileen Hileman on March 15, 2000 at Glover Middle School, Spokane, Washington. Photograph 13 shows a tar-like substance to the right of the capacitor within the ballast fixture in the main hallway, next to Room 127.

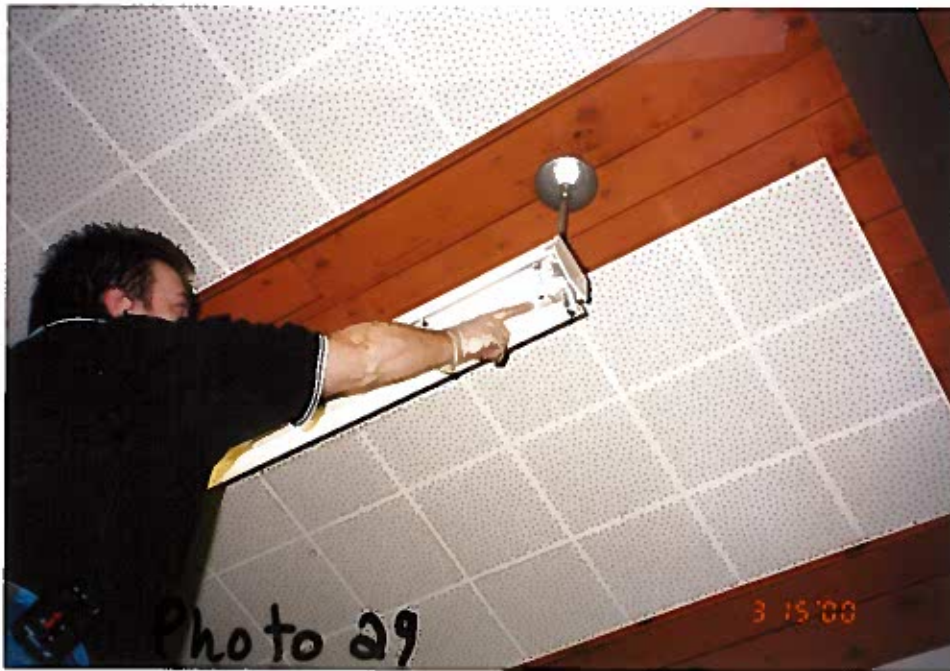
Photograph 29 taken by Eileen Hileman on March 15, 2000, at Glover Middle School, Spokane, Washington. Photograph 29 shows a tar-like substance on the external surface of a ballast cover of a fluorescent light fixture located in the hallway outside room 156.

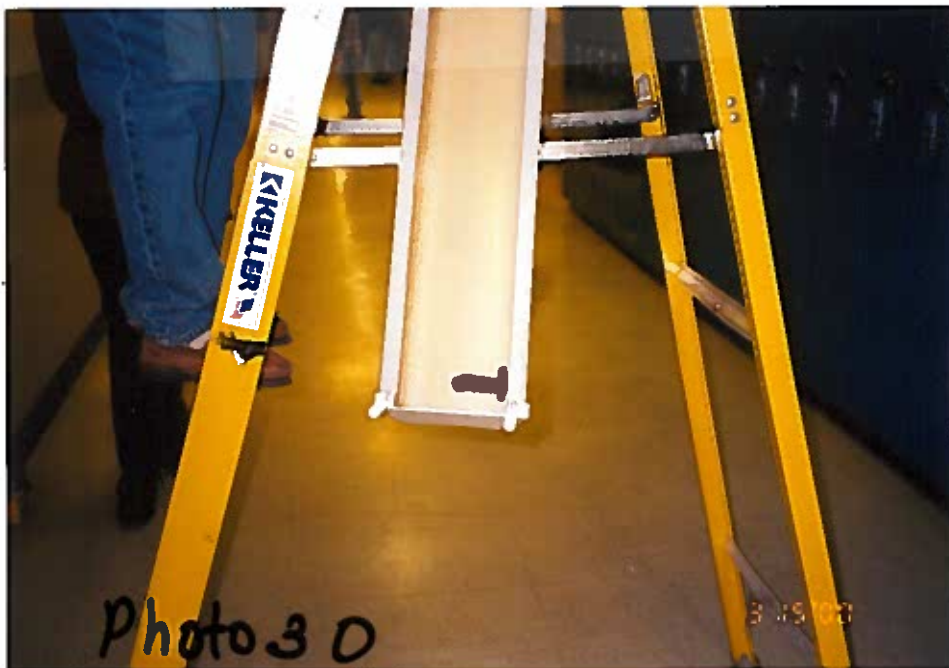
Photograph 30 taken by Eileen Hileman on March 15, 2000, at Glover Middle School, Spokane, Washington. Photograph 30 shows there was a tar-like substance on the internal surface of the light cover located in the hallway outside Room 156.

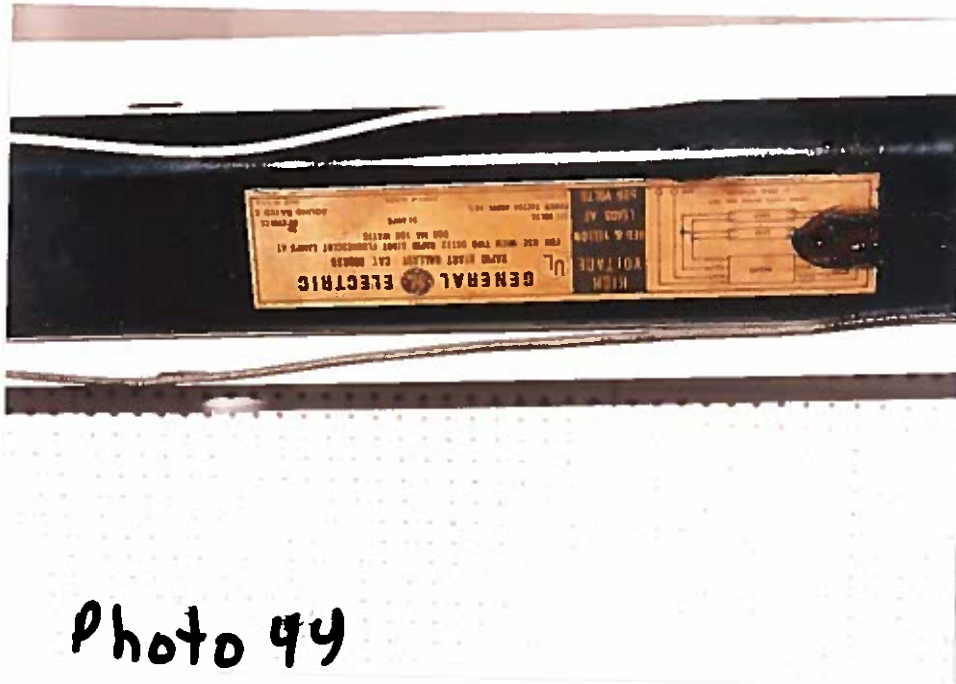
Photo 44

The next ballast examined in room 149 was directly above a student's desk. The capacitor had ruptured and there was a tar-like substance on the external surface of the capacitor (photograph 44) and there was tar-like substance on the ballast cover (photograph 45). The capacitor was a GE rapid start ballast and appeared to be very old and was leaking. There was no indication on the nameplate as to the PCB content in the capacitor nor was there a manufacture date on the nameplate.

Photograph 44 taken by Eileen Hileman on March 15, 2000, at Glover Middle School, Spokane, Washington. Photograph 44 shows the next ballast examined in Room 149 was a GE capacitor. The capacitor had ruptured and there was a tar-like substance on the external surface of the capacitor. There was no indication as to the PCB content nor was a manufacture date listed on the nameplate.
